ASSESSMENT OF CONSTRUCTION QUALITY OF DILAPIDATED INCOMPLETE GOVERNMENT RESIDENTIAL BUILDINGS FOR CHECKING THE POSSIBILITY OF FURTHER CONSTRUCTION

Dr. S.K. Sohani¹, Deepshikha Shukla², Ankit Shah³, Darpan Keshore⁴
Acropolis Institute of Technology and Research, Indore (M.P.), India

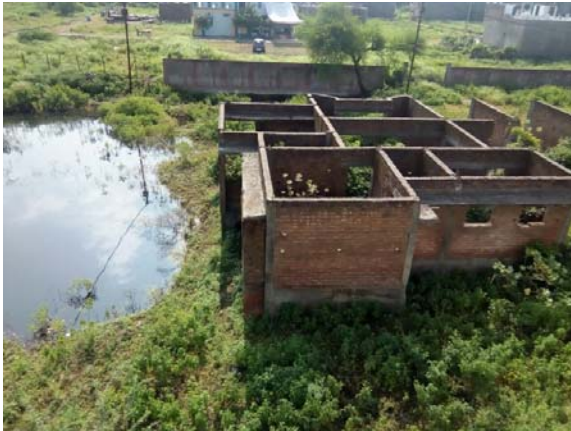
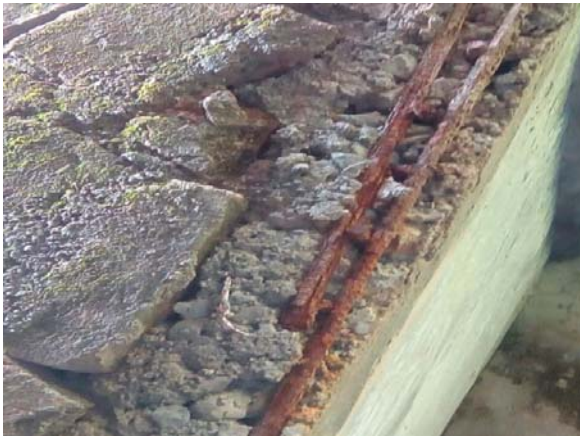
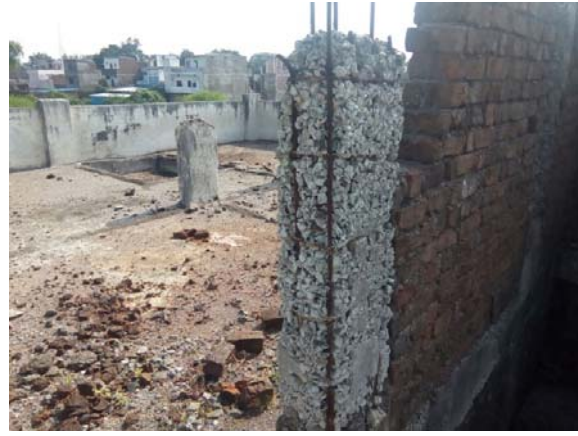
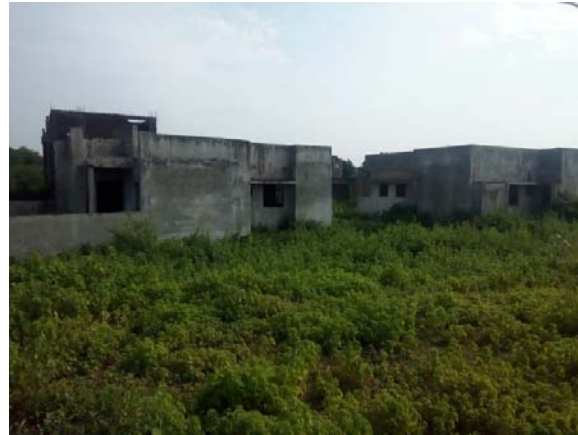
The photographs below shows the actual site conditions before performing the test for the evaluation of the strength and quality of the already constructed portion. As shown in the first photo below, lot of water clogging can be seen which will percolate in the soil increasing the moisture content of the soil in adjoining areas.

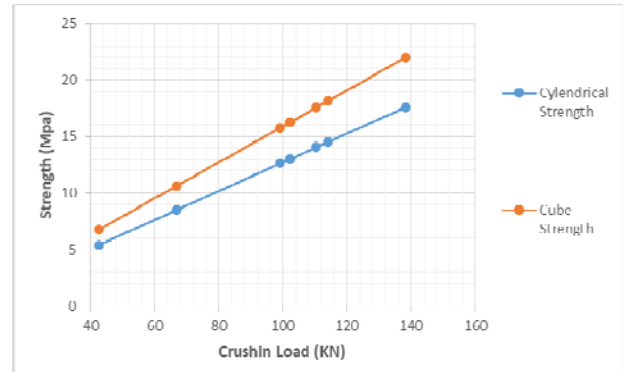
Fig4: Graph between Crushing Load and Strength for Cube and Cylinder

The comparison of the results so obtained are shown graphically. The graphs are prepared between different parameters.
